# CHOPPER-CONTROLLED DISCHARGE LIFE CYCLING STUDIES ON LEAD-ACID BATTERIES

## FINAL REPORT

by Joseph J. Krami and Ernest P. Ames  
TRW SPACE AND TECHNOLOGY GROUP

**APPENDIX A**  
**EV-106 LEAD-ACID BATTERY FAILURE NO. 16 (S/N 097)**  
**SAMPLE REPORT**

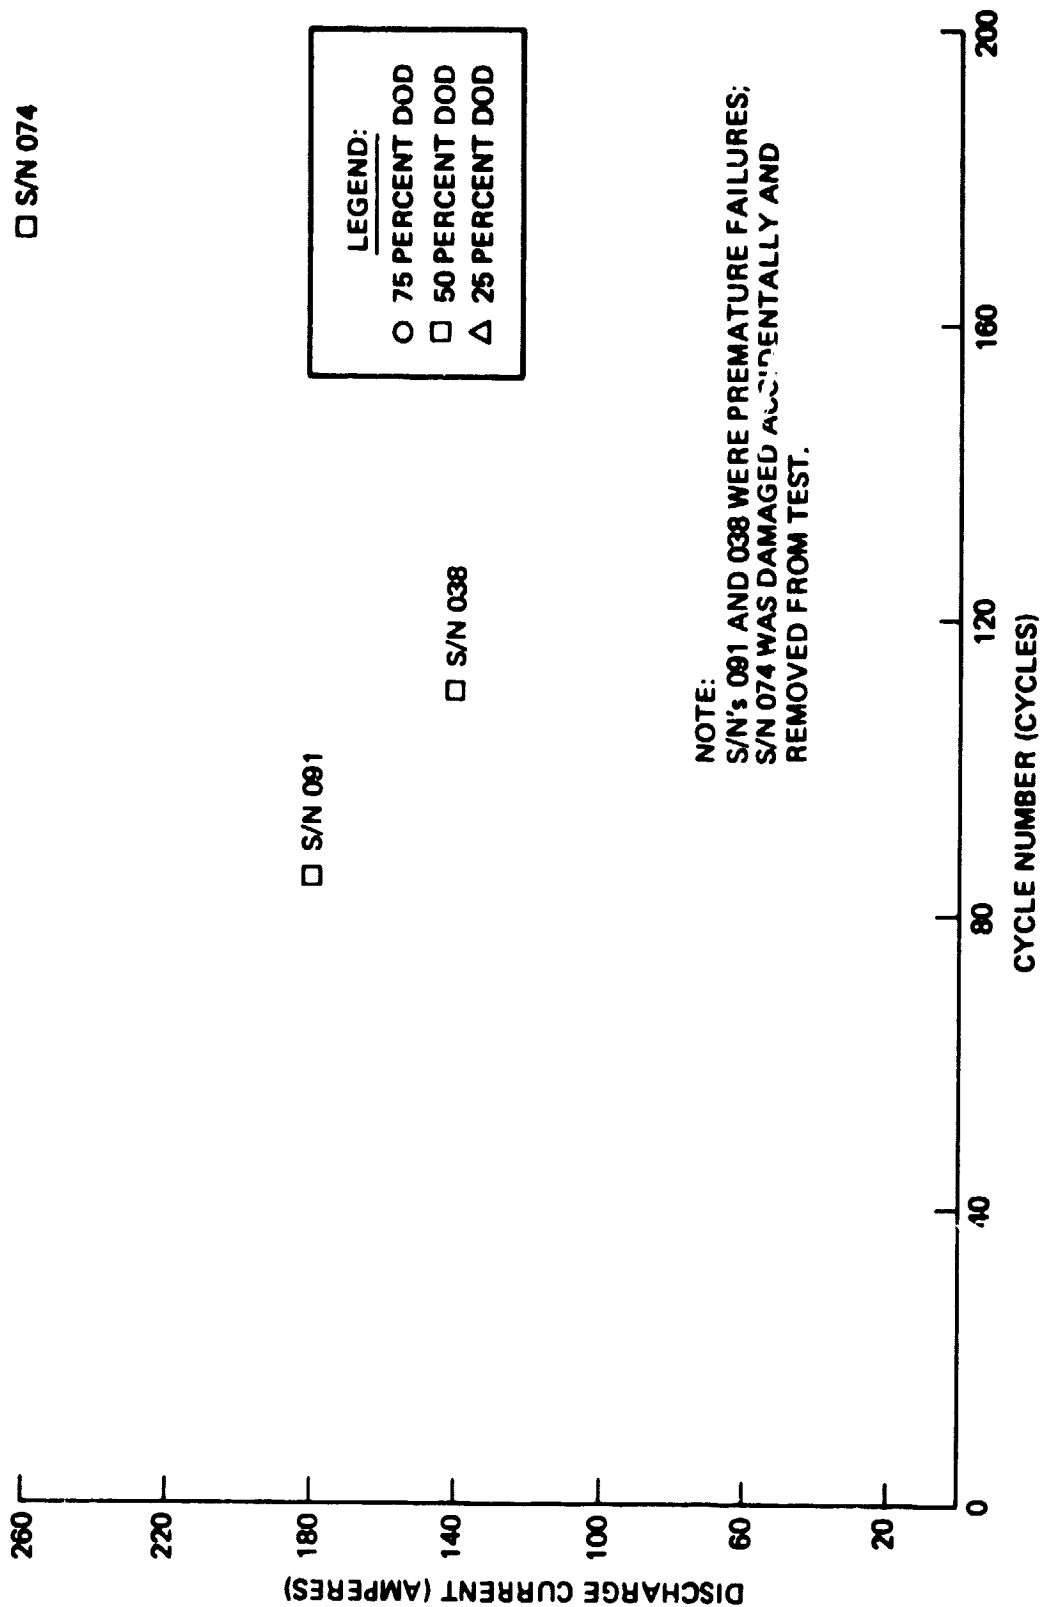
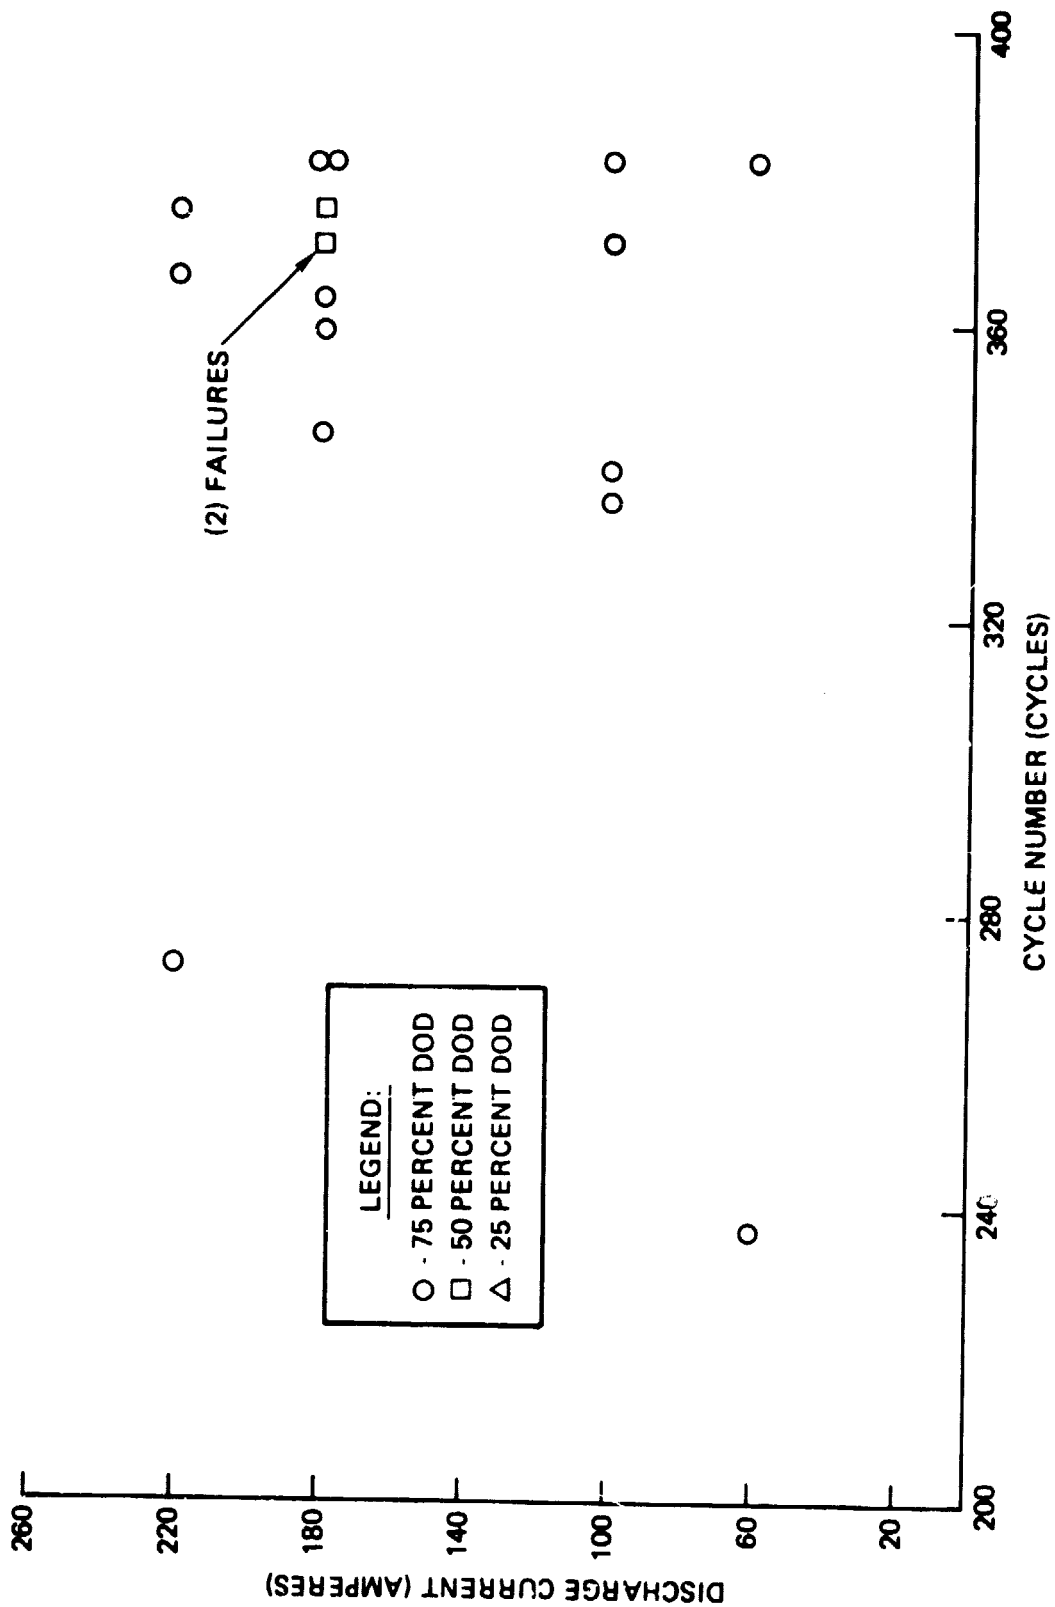
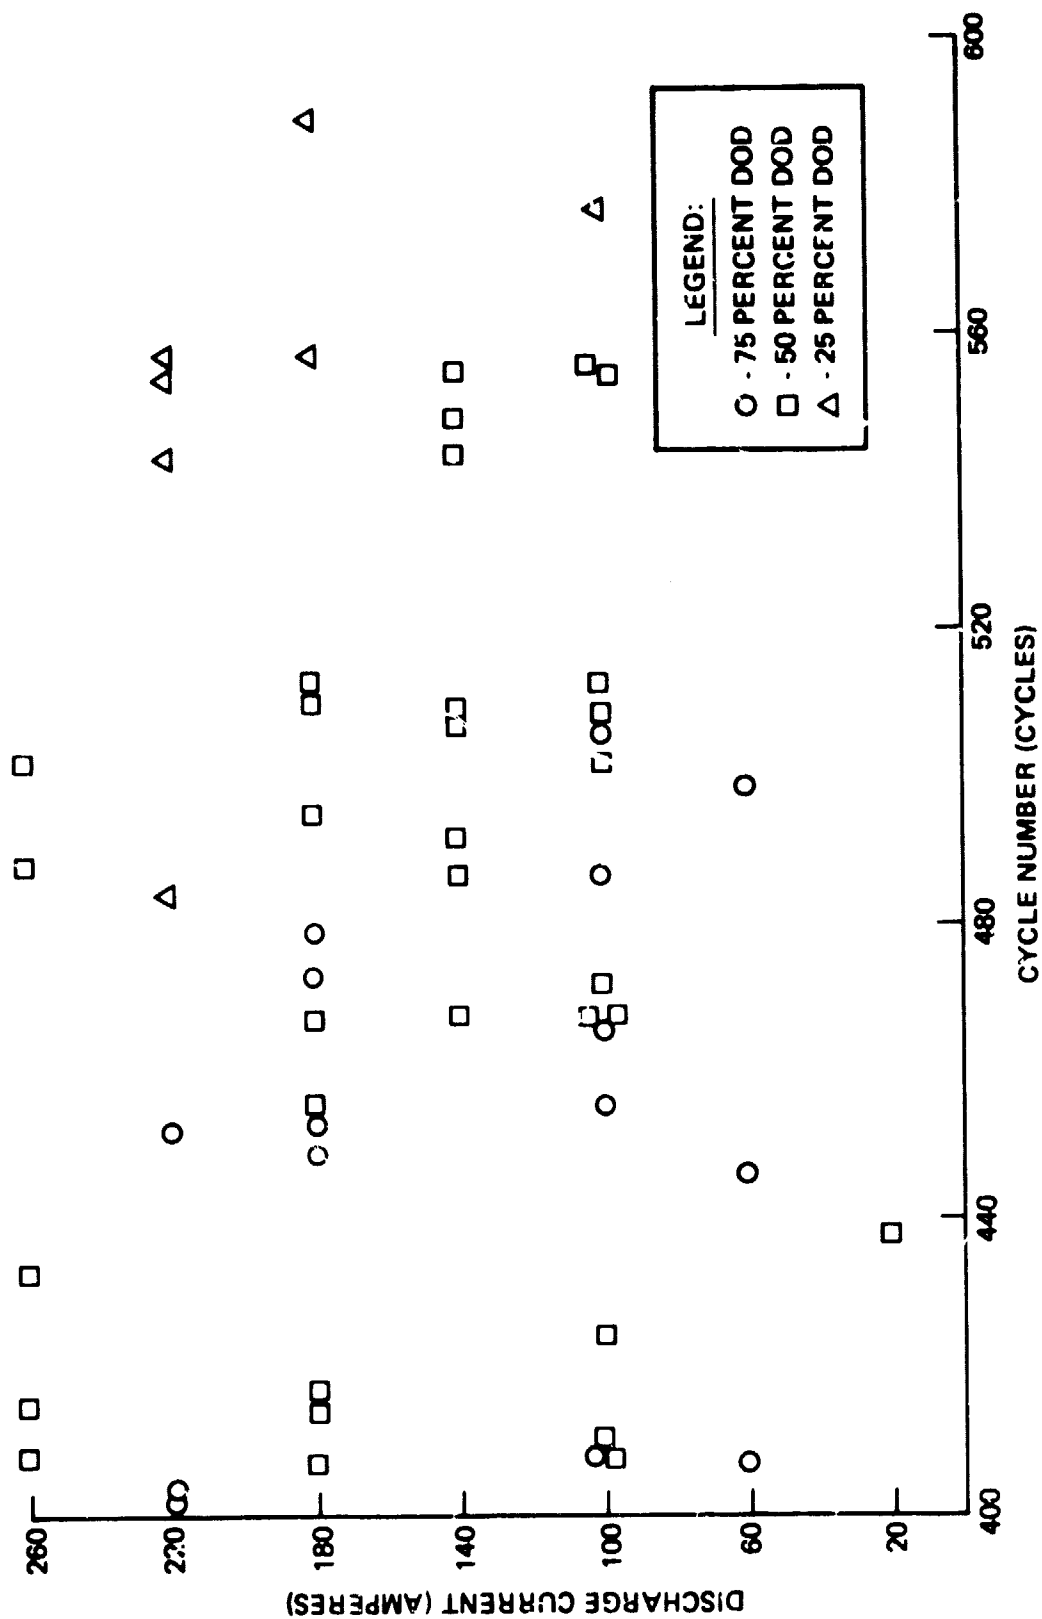
Figure 11. Failure Distribution, Cycle Life Versus Current/DOD
